RCC Panel 6 Foam Impact Test Results (Preliminary)

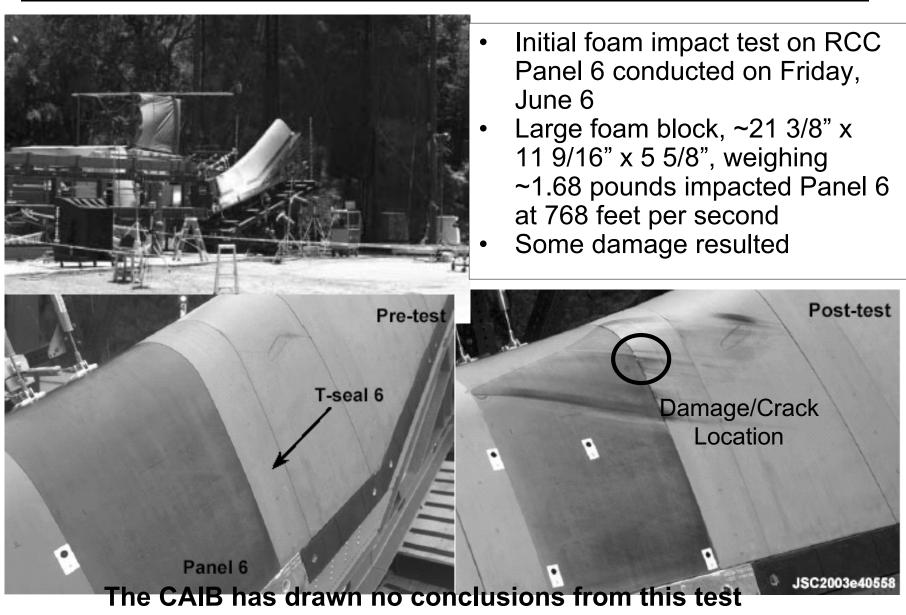
- 5 1/2" long through-thickness crack
- Located on the lock side approximately 6" below the stagnation line (apex)
- Transverses the entire rib width, extends through the lock side channel and onto the panel lower face
- Approximately 3/4" crack on the lower face
